Test Report

To	Clear-az-Glass Fencing Unit 8 / 57 Paramount Drive Wangara WA 6065	Report No.	MTS-20834 CAZG
Order No.	Att: C. Bain	Issue Date	6/05/2015
		Test Date	5/05/2015

MTS Metallurgical Testing services was engaged to witness the installation and to perform load tests on a square stainless steel post in general accordance with the requirements of AS 1926.1 - 2012.

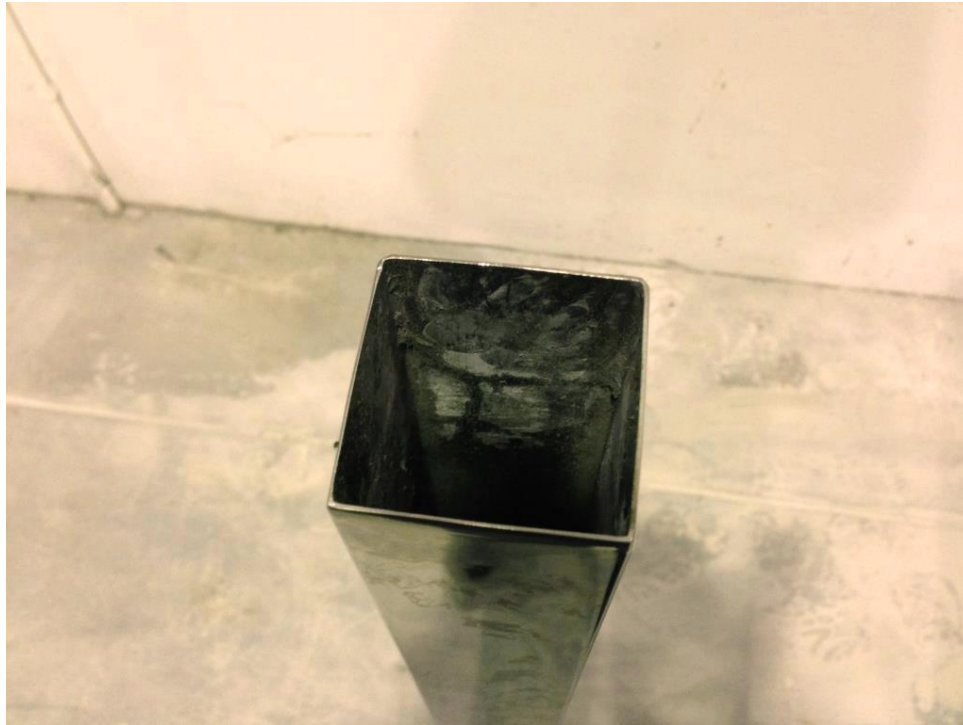
The square stainless steel post

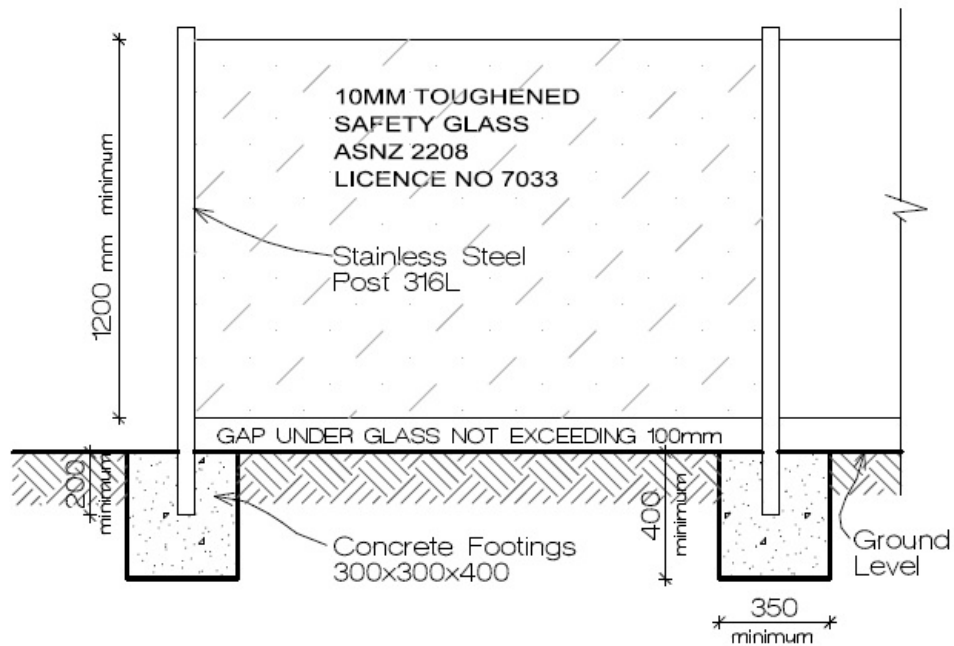
The post was installed in general accordance with the details of this drawing, modified to suit 125mm thick floor at the test site.

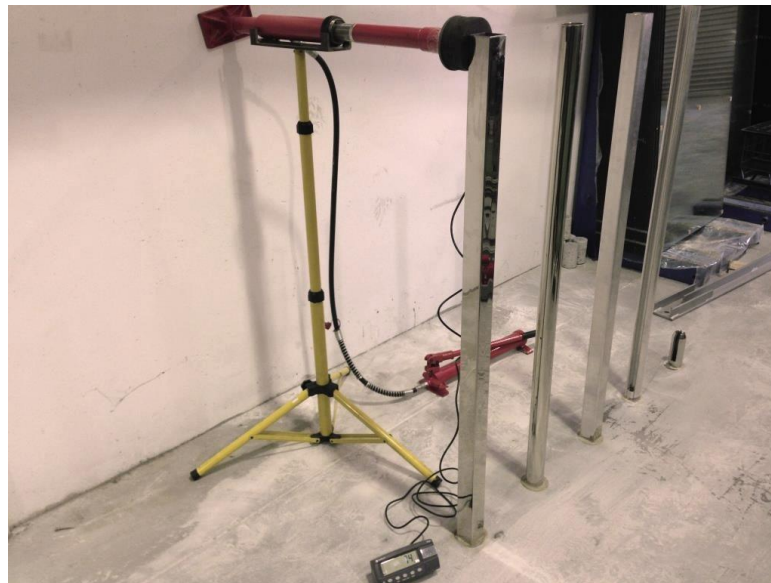
Specimen ID	Test Load (N)	Deflection Under Load (mm)	Permanent Distortion (mm)	Observations	Assessment
20834/01	330	12.0	0.0	No damage or looseness of footing was evident.	COMPLIES

The post under test.
