Test Report

To Clear-az-Glass Fencing Report No. MTS-20835 CAZG

MTS Metallurgical Testing services was engaged to witness the installation and to perform load tests on a round stainless steel $\,$ post in general accordance with the requirements of AS 1926.1 - 2012.

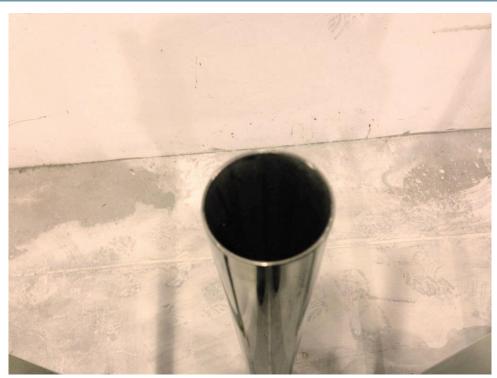
Round stainless steel post

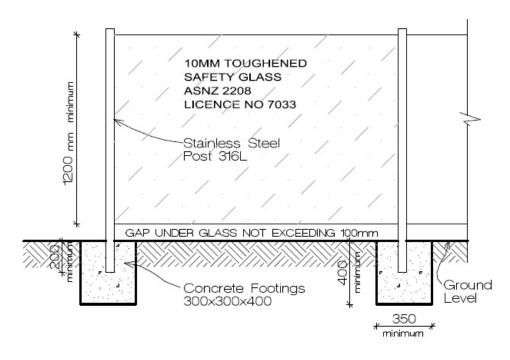
The post was installed in general accordance with the details of this drawing, modified to suit 125mm thick floor at the test site.

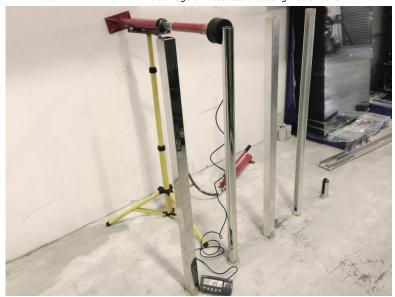
Specimen ID	Test Load	Deflection Under Load	Permanent Distortion	Observations	Assessment
	(N)	(mm)	(mm)		
20835/01	330	10.0	1.0	No damage or looseness of footing was evident.	COMPLIES

The post under test.
