MTS Metallurgical Testing Services
ABN 54 122 133 331
3/52 Cocos Drive Bibra Lake Western Australia 6163
Tel 08 9418 6380 Fax 08 9434 1328

Test Report

Report No. **MTS-20838 CAZG**
Issue Date 8/05/2015
Test Date 5/05/2015

MTS Metallurgical Testing services was engaged to witness the installation and to perform load tests on a pool fence gate and gate post in general accordance with the requirements of AS 1926.1 - 2012.

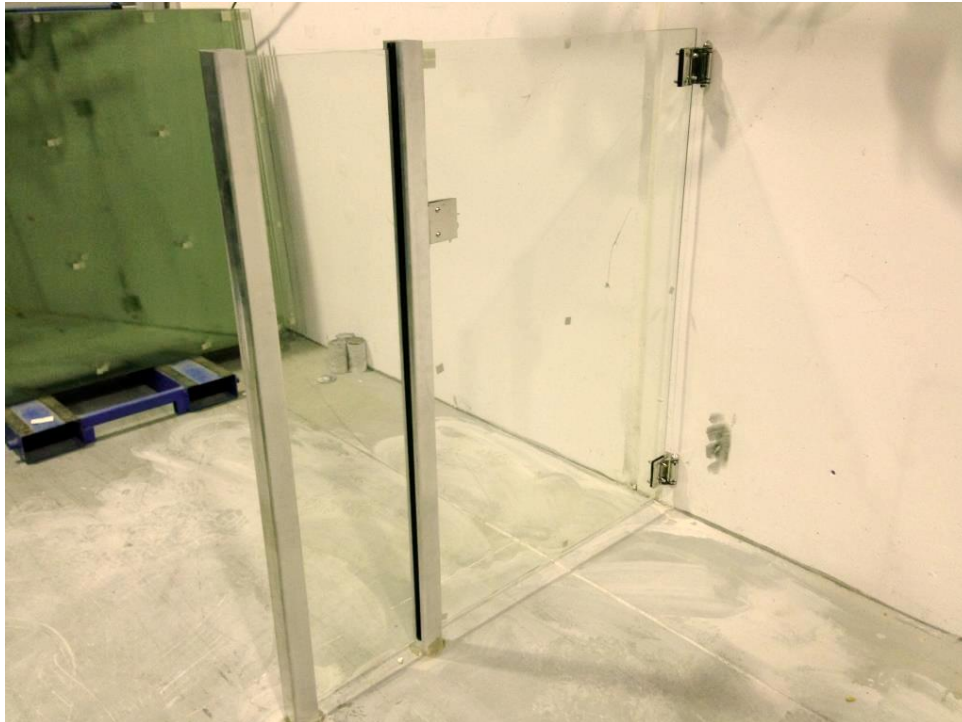
The Gate and Gate Post.

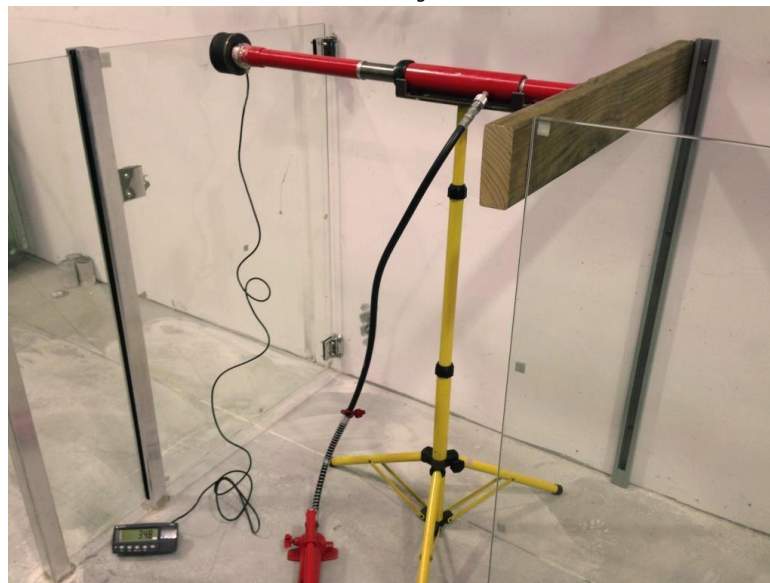
Specimen ID	Test Load (N)	Deflection Under Load (mm)	Permanent Distortion (mm)	Observations	Assessment
20838/01	330	8.0	0.0	No breakage, fracture or permanent deformation was evident. The latch did not unintentionally release during the test. After the test the automatic closing function was intact.	COMPLIES

The gate under test - Position 1

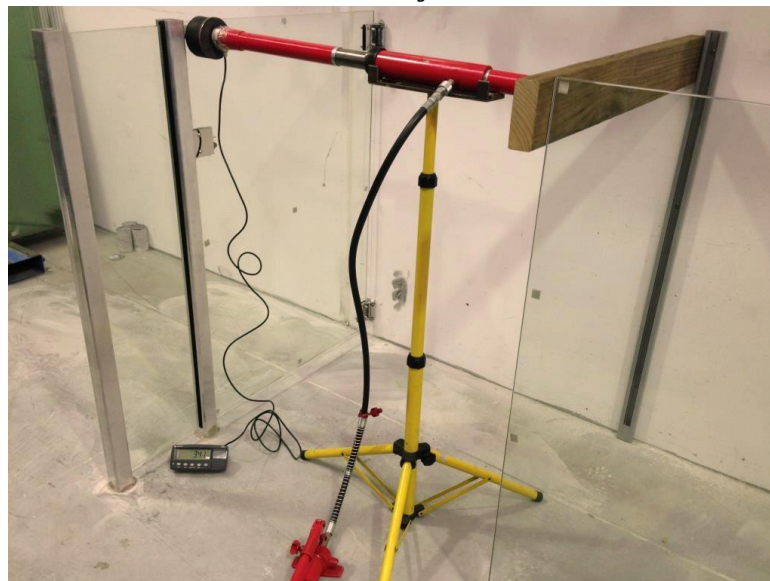
20838/01	330	5.0	0.0	No breakage, fracture or permanent deformation was evident. The latch did not unintentionally release during the test. After the test the automatic closing function was intact.	COMPLIES
----------	-----	-----	-----	--	----------

The gate under test - Position 2

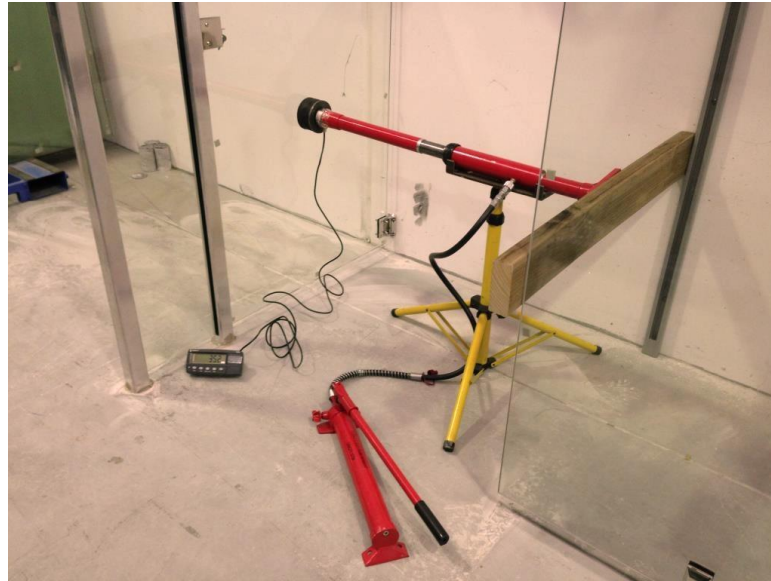
Specimen ID	Test Load (N)	Deflection Under Load (mm)	Permanent Distortion (mm)	Observations	Assessment
20838/01	330	10.0	0.0	No breakage, fracture or permanent deformation was evident. The latch did not unintentionally release during the test. After the test the automatic closing function was intact.	COMPLIES

20838/01	330	24.0	0.0	The gate under test - Position 3 No breakage, fracture or permanent deformation was evident. The latch did not unintentionally release during the test. After the test the automatic closing function was intact.	COMPLIES
----------	-----	------	-----	--	----------

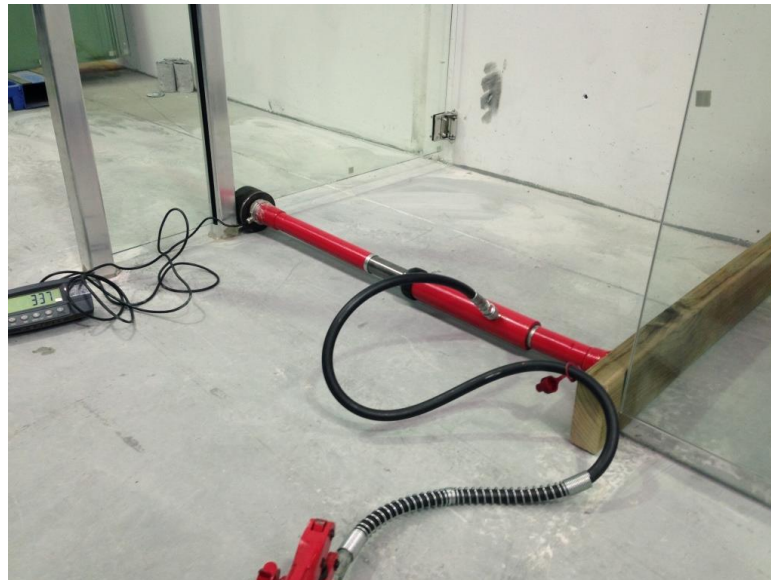
The gate under test - Position 4

The gate was load tested in five locations including at its weakest point (Position 4).

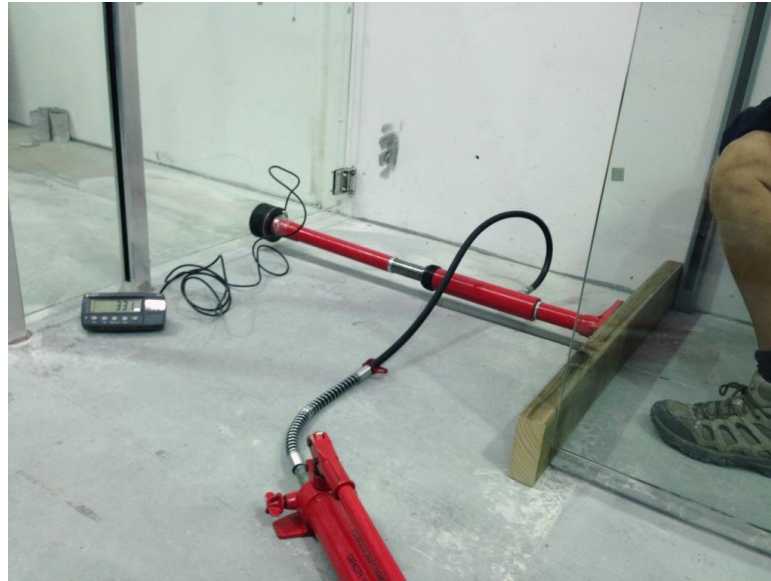
Specimen ID	Test Load (N)	Deflection Under Load (mm)	Permanent Distortion (mm)	Observations	Assessment
20838/01	330	16.0	0.0	No breakage, fracture or permanent deformation was evident. The latch did not unintentionally release during the test. After the test the automatic closing function was intact.	COMPLIES

The gate under test - Position 5

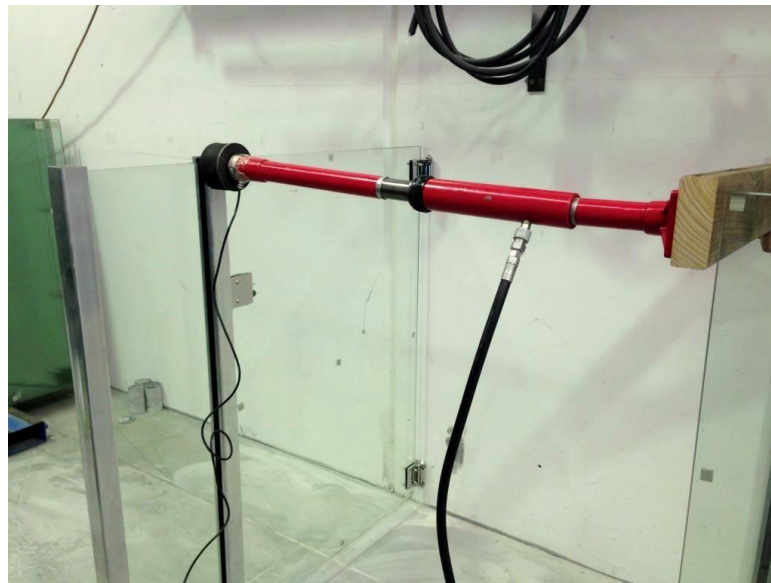
Specimen ID	Test Load (N)	Deflection Under Load (mm)	Permanent Distortion (mm)	Observations	Assessment
20838/01	330	13.0	0.0	No permanent deformation was evident.	COMPLIES

The gate post under test.
